LAWRENCE
LIVERMORE
NATIONAL
LABORATORY

Final Report: Posttest Analysis of Omega II Optical Specimens

C. D. Newlander, J H Fisher

February 1, 2007

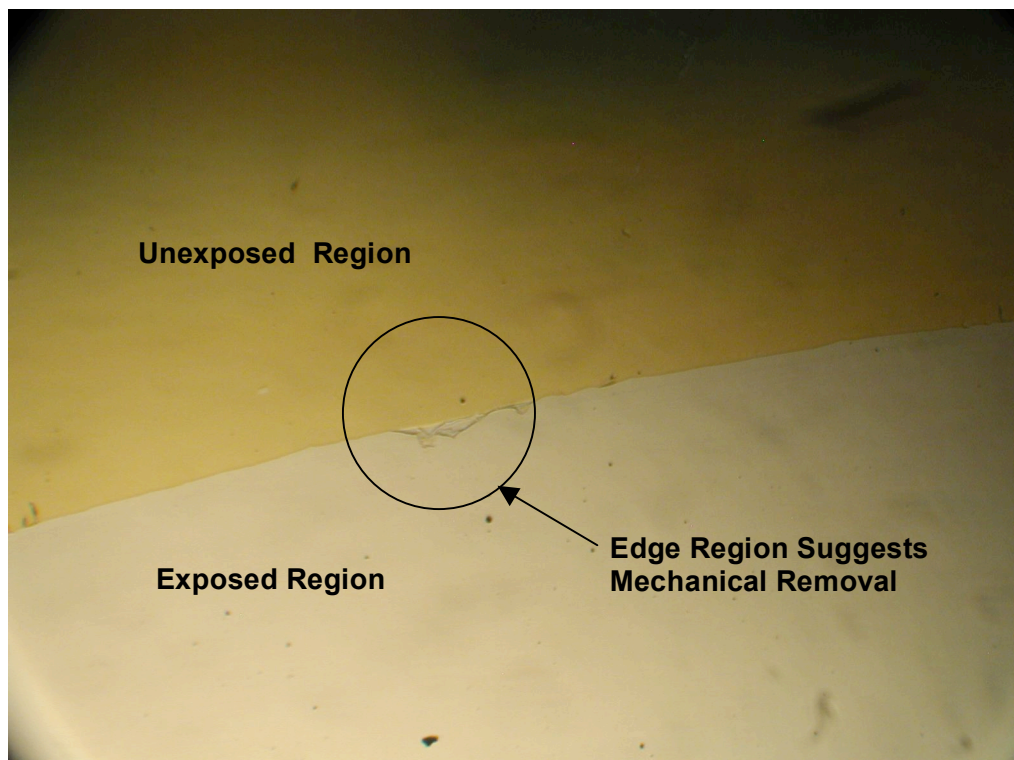
Shot	Specimen	Visual Observations
52	1	Outer layer(s) completely removed over entire exposure area. Based on reflectance data, the silica layer has been removed. Analyses and exposure area edge description suggest mechanical removal, not melt or vaporization. Gold layer appears to be intact
53	6	Only two photomicrographs available. One very small area shows removal of silica (folded back on itself indicating mechanical interface failure. Remaining silica and gold coatings remain intact and undamaged
54	5	Photomicrographs do not appear to be in focus. No damage to either coating is evident.
56	8	Silica coating removal at several areas. These areas appear to be a small percentage of the total exposed area. Close-ups of damaged area shows solid silica coating debris and folding of the layer at numerous locations. There may be several areas of cracking/splitting of the gold coating. These could be posttest scratches.

Figure 6. Photomicrograph of Specimen 1 (Shot 52). Silica Coating Layer Completely Removed Over Exposed Region.

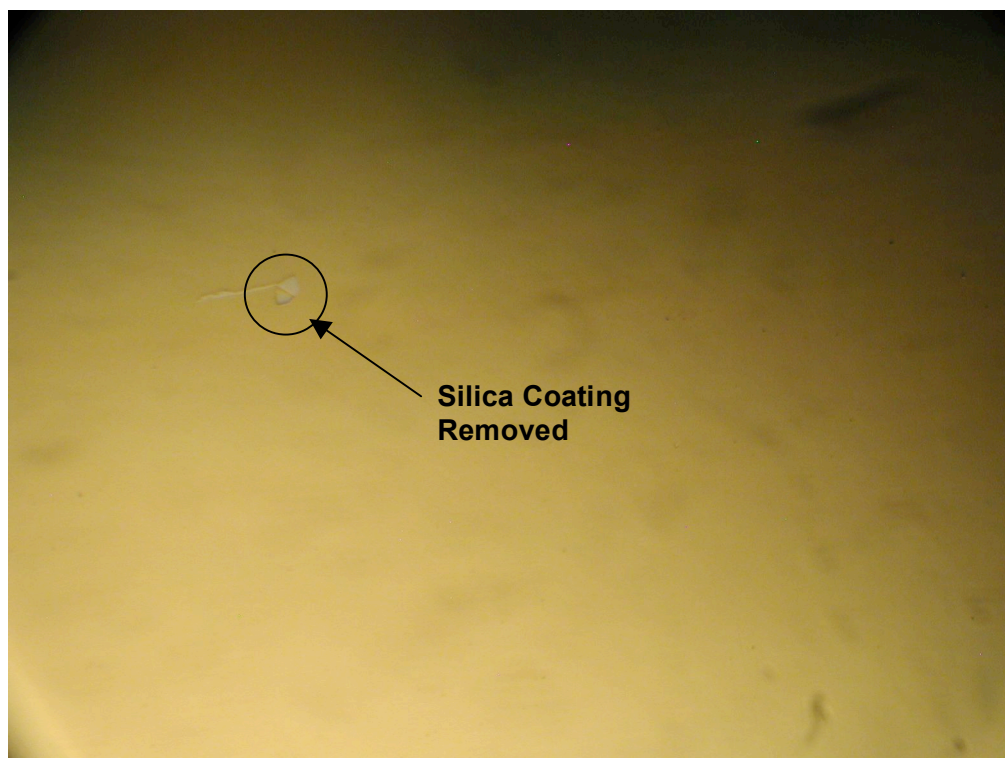
Figure 7. Photomicrograph of Specimen 6 (Shot 53). Silica Coating Layer Removed Over A Very Small Region.

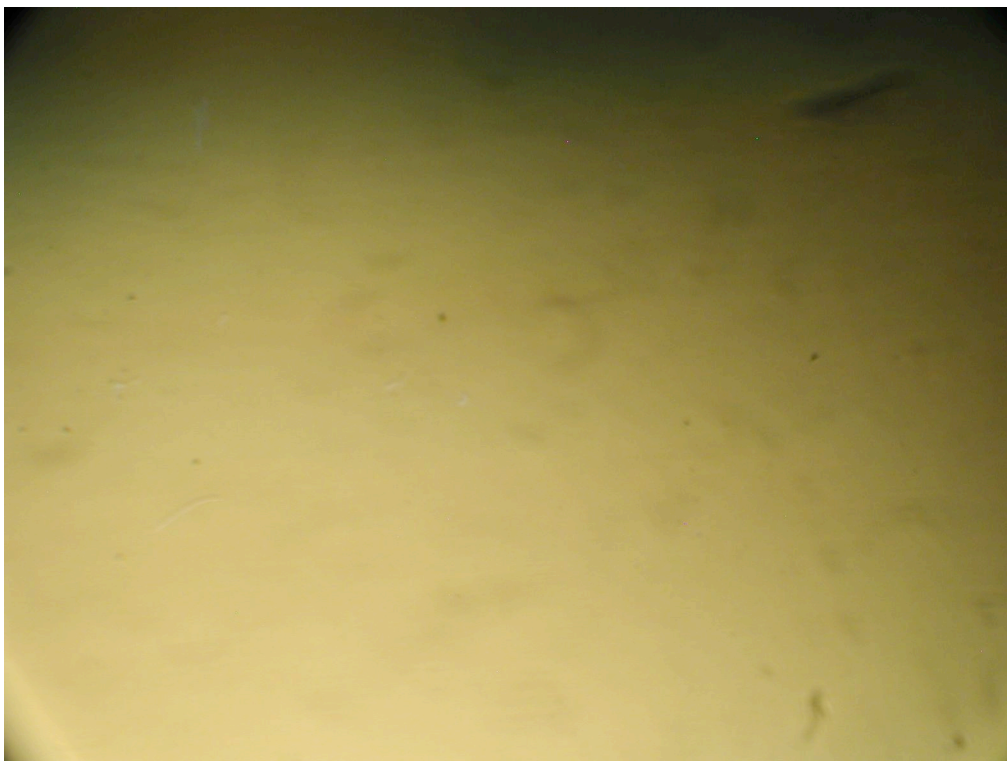
Figure 8. Photomicrograph of Specimen 5 (Shot 54). No Apparent Damage to Either Coating.

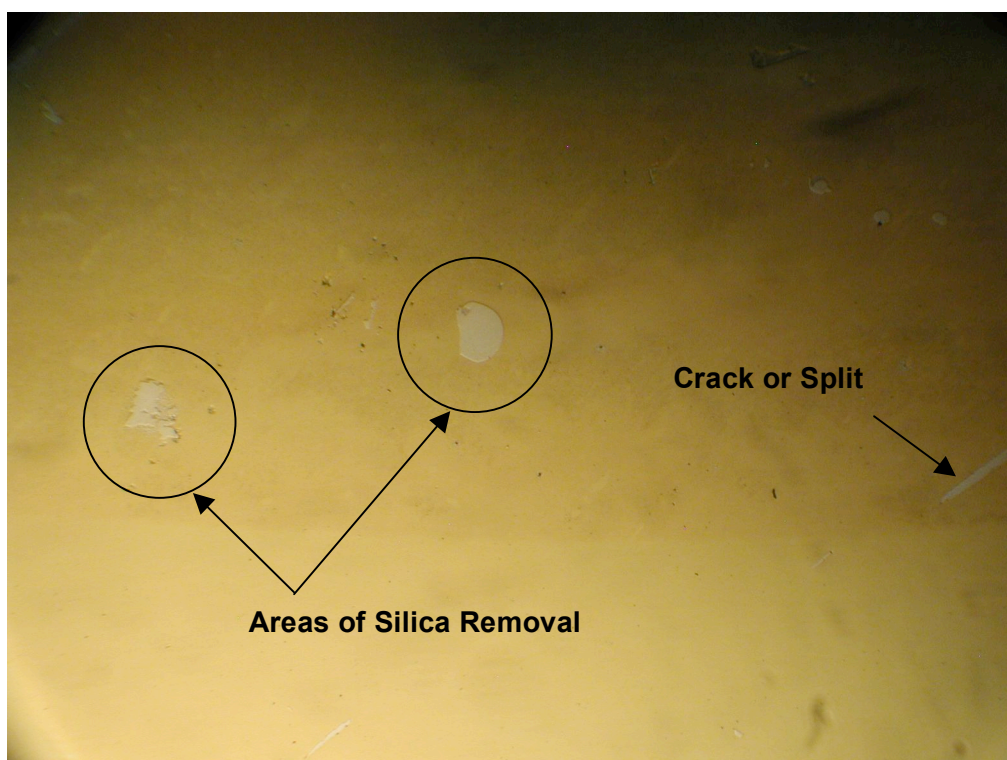
Figure 9. Photomicrograph of Specimen 8 (Shot 56). Complete Silica Coating Removal Over Several Areas. Several Cracks or Splits Observed in the Silica Layer.

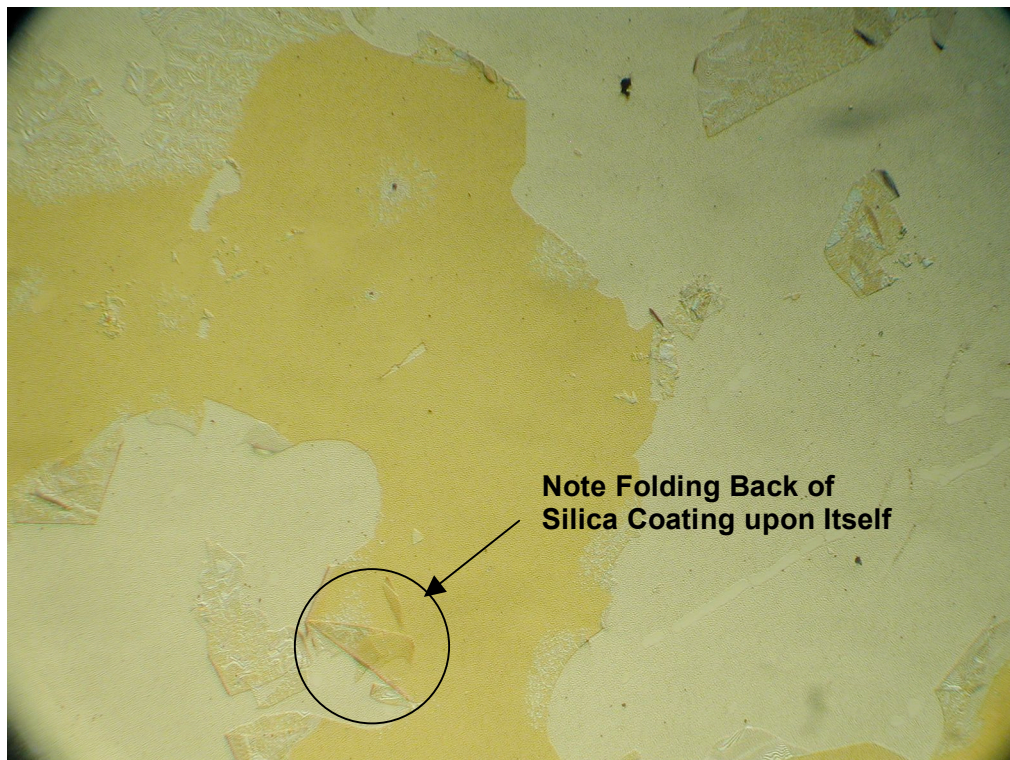
Figure 10. Close-Up of Specimen 8 (Shot 56) Showing Coating Removal And Fold-Over In Several Locations.

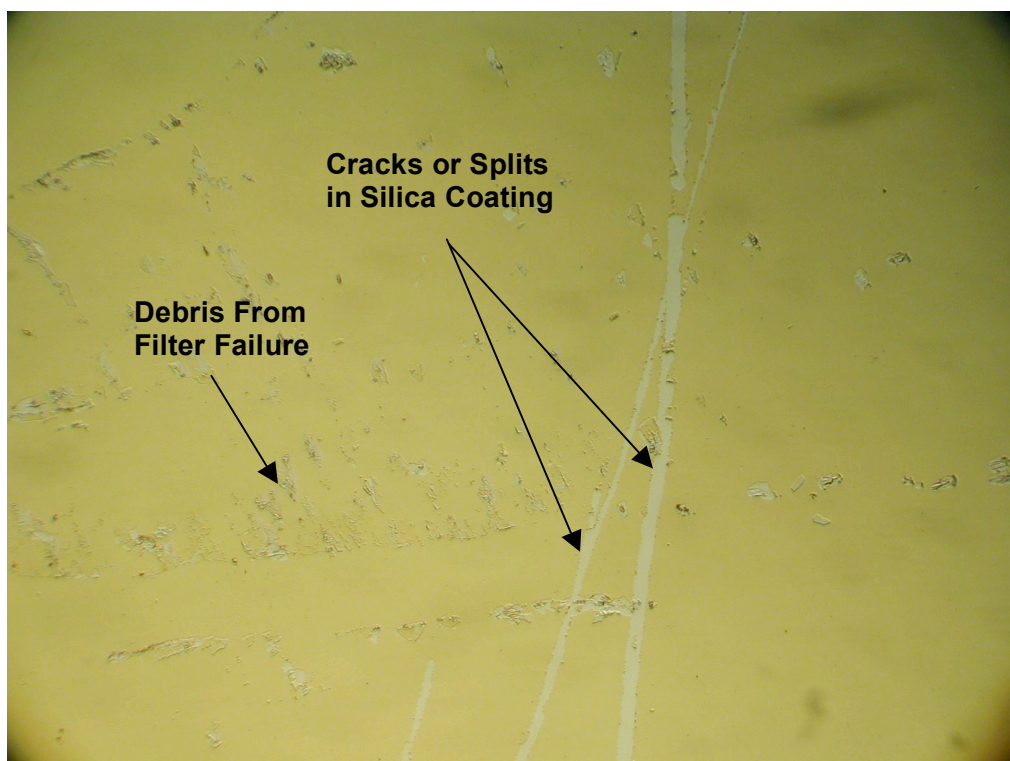
57	4	Beryllium filter fractured and failed on this shot. Specimens shows debris on the surface. There are also several long cracks/splits in the silica coating. The cause of the cracks/splits is unknown but could related to the debris impact or posttest scratches.
58	7	Photomicrographs do not appear to be focus. No damage to either coating is evident.

Figure 11. Photomicrograph of Specimen 4 (Shot 57) Showing Debris From Filter Failure and Cracks/Splits in Silica Coating.

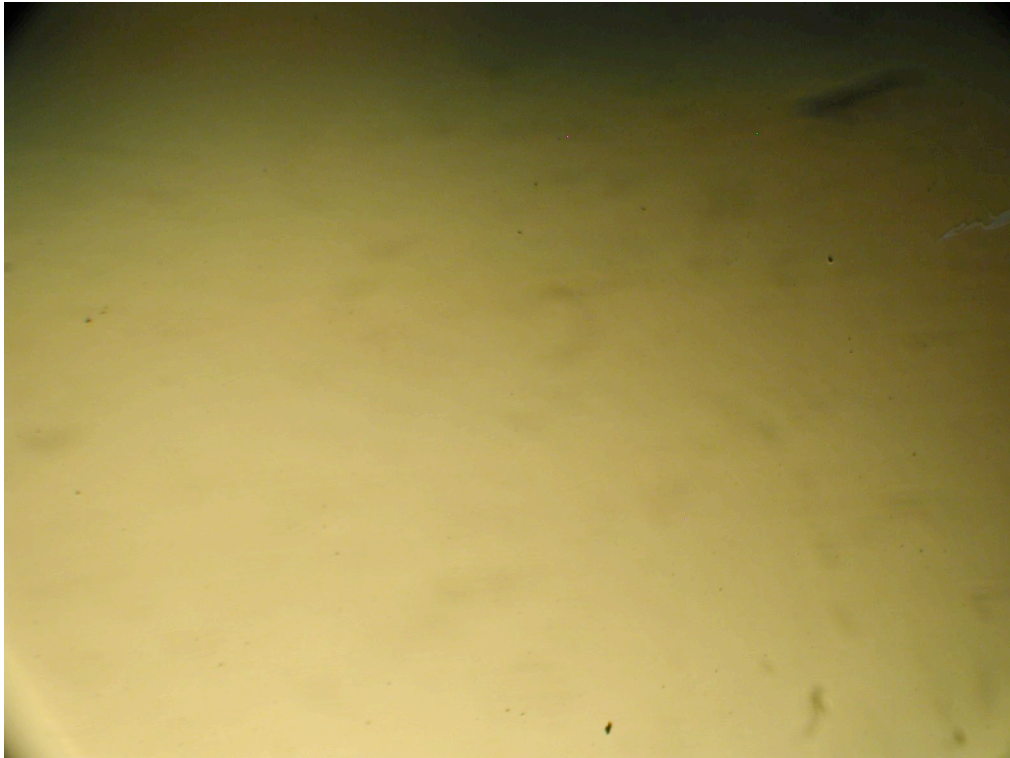
Figure 12. Photomicrograph of Specimen 7 (Shot 58). No Apparent Damage to Either Coating.

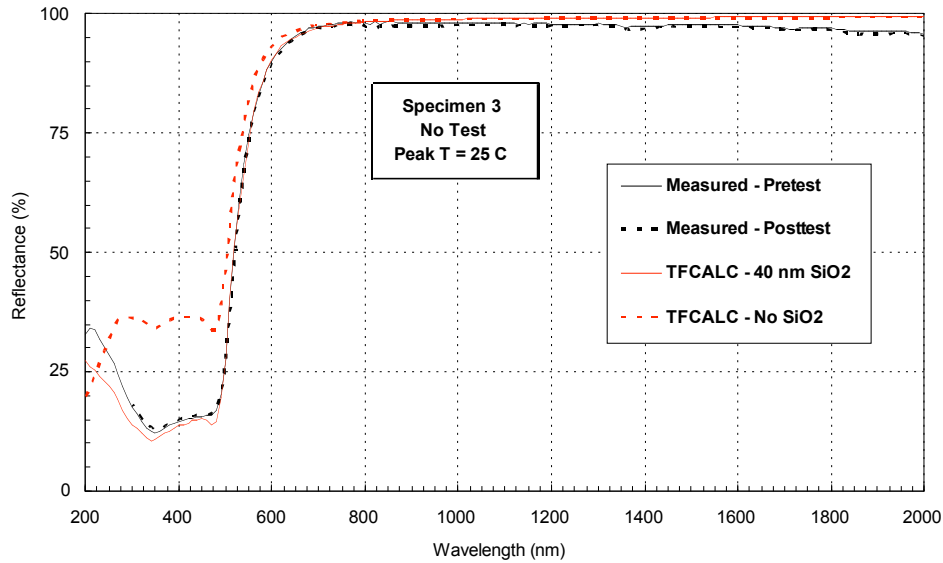
Figure 13 shows the measured pre- and posttest reflectance for Specimen #3 which was untested and therefore should show no effect of any X-ray exposure, but only the effects of handling and any laboratory testing. The pre- and posttest curves lie practically on top of each other. There is no degradation at any wavelength.

Figure 13. Pre- and Posttest Reflectance Measurements of Specimen #3 (Untested and Therefore No X-ray Effects)

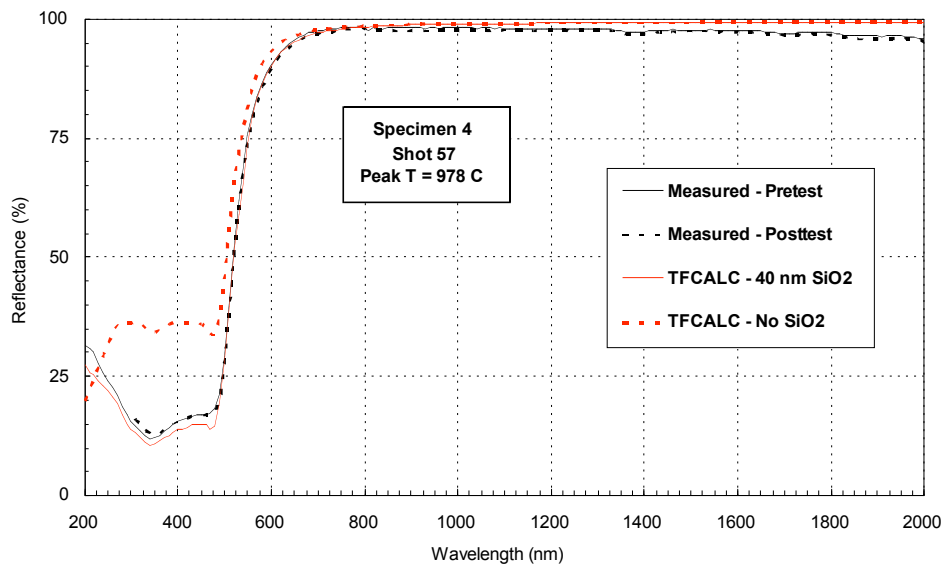
Figure 14 shows the results for Specimen #4 tested on Shot 57. This specimen was tested at the conditions designed to produce the lowest peak temperatures in any of the layers and the nominal fluence should produce peak temperatures below the melt temperatures of any of the layers. The filter for this specimen failed, and some debris on the surface was evident. In addition, several cracks or splits in the silica coating were seen in the photomicrographs. Again, the pre- and posttest curves lie practically on top of each other. There is no degradation in reflectance at any wavelength.

Figure 14. Pre- and Posttest Reflectance Measurements of Specimen #4 Tested on Shot 57. The Filter Failed On This Shot and Debris Was Detected On the Specimen Surface Along With Several Cracks/Splits in the Silica Coating Of Unknown Origin.

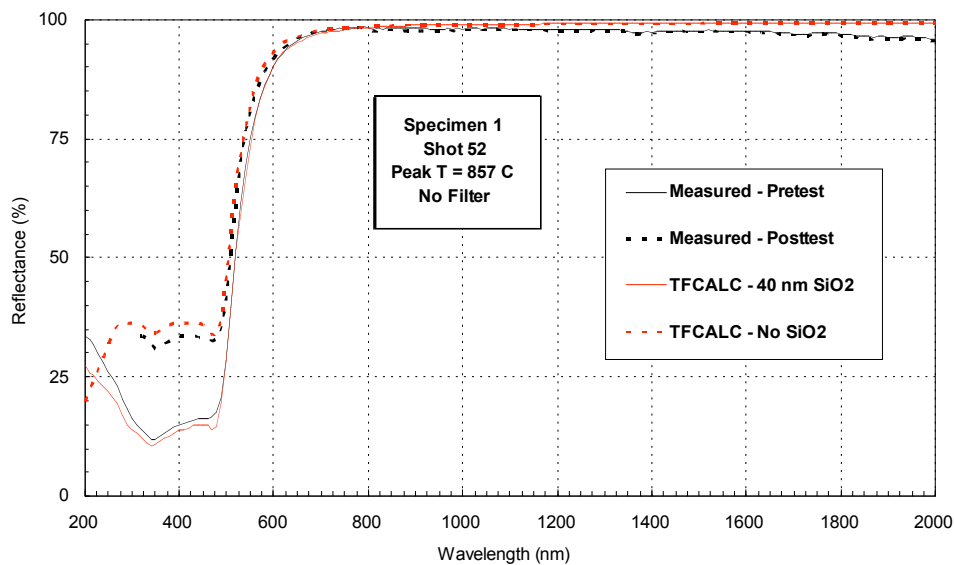
Figure 15 shows the results for Specimen #1 tested on Shot 52. The photomicrographs indicated that the entire silica protective coating layer had been removed by the X-ray exposure. The posttest measurements show enhanced reflectance in the UV and visible wavelengths. The TFCALC calculation without the silica overcoat matches the measured reflectance well and indicates that the gold layer was basically undamaged. There was no change in the reflectance above 800 nm which again suggests that the gold reflecting layer was undamaged by the X-ray exposure or the removal of the silica layer. This suggests that the gold layer probably did not melt.

Figure 15. Pre- and Posttest Reflectance Measurements of Specimen #1 Tested on Shot 52. The Silica Coating Layer Was Completely Removed From the Exposed Region By Mechanical Response.

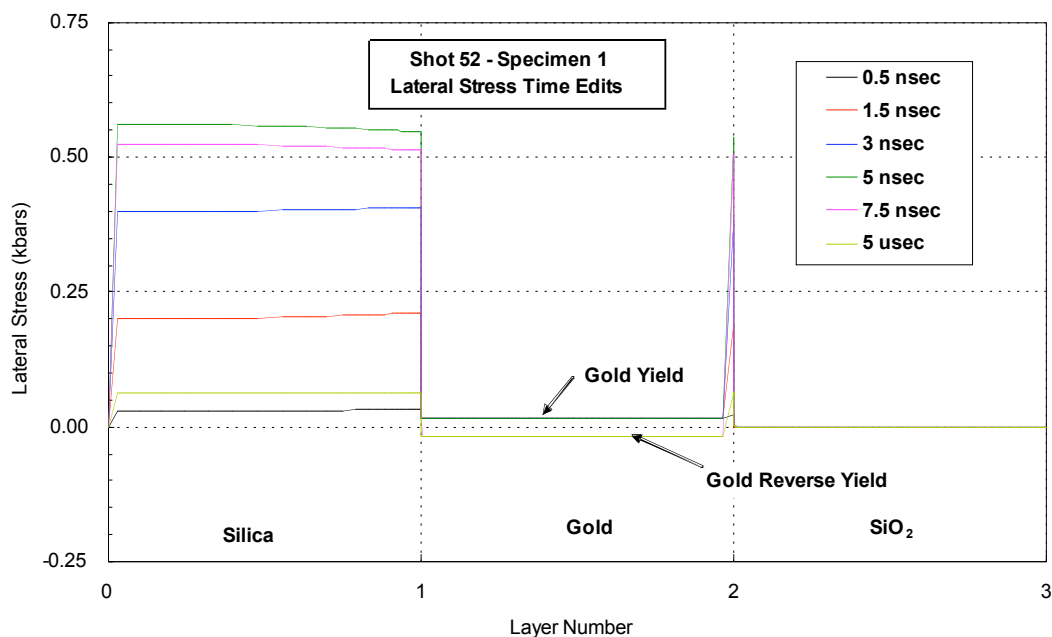
Figure 20 shows the calculated lateral stresses for Shot 52 versus layer number at various times (the PUFFTFT code is currently not set up to generate peak lateral stress envelopes). The figure indicates that the peak stresses are generated near 5 nsec. The analysis indicates that the stress difference between the silica and gold layers is about 0.55 kbars. This is a substantial stress and may well have exceeded

the shear strength between the layers. However, the analysis also shows that the gold layer has yielded through the thickness. The gold was assumed to be annealed and have a yield strength of less than 0.02 kbars. The gold also shows reverse yield as the material cools at later times. The results are also predicated upon the properties of the silica protective coating which was assumed (for material property definition) to be fused silica with a yield strength of 15 kbars. However it is also assumed to have a very low CTE of 0.55 which will reduce the lateral stresses. It is also interesting to note that the fused silica substrate (which really is fused silica) induces large lateral stresses at the gold/substrate interface. However, no mechanical removal of the gold layer was observed. The interface strength between the gold and the substrate may be much larger than the strength between the two coating layers.

Figure 20. Lateral Stresses Calculated For Shot 52 – Specimen #1

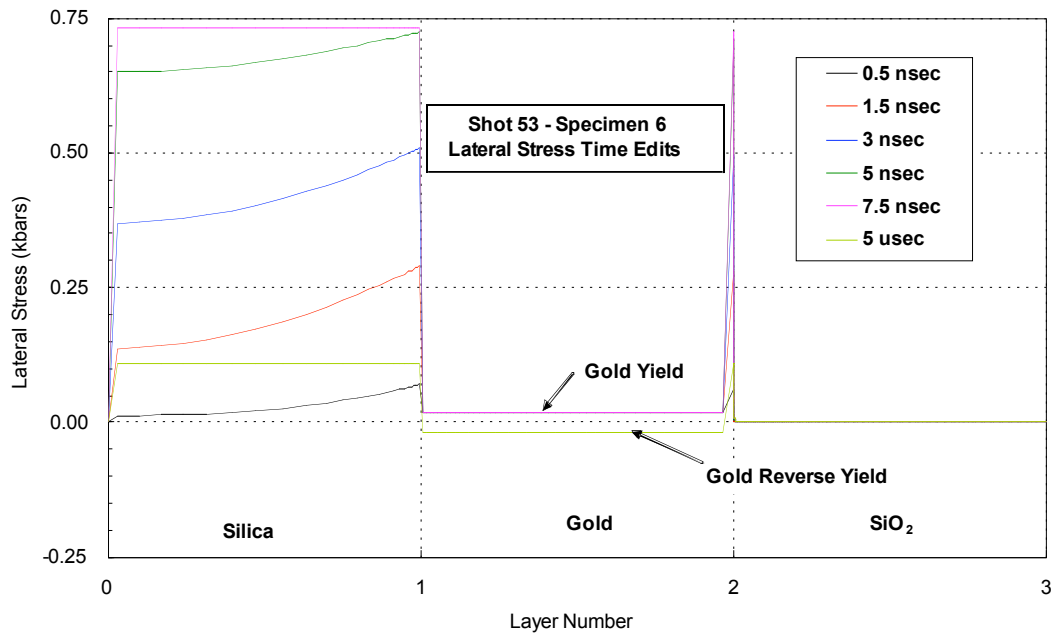
These results can be compared to the lateral stresses calculated for Shot 53 (shown in Figure 21) which showed no removal of the silica coating. Shot 53 was filtered and had a shorter FWHM. The calculated peak temperatures using the nominal fluences were higher than those calculated for Shot 52. Because Shot 53 was filtered, the lateral stresses in the silica protective layer are the result of the temperature being conducted from the gold layer rather than the direct deposition. However the lateral stresses calculated at the silica-gold interface are much higher in Shot 53 than in Shot 52. Figure 22 shows the results for Shot 56 – Specimen #8 which had the very highest calculated gold temperatures. The calculated interface lateral stresses are similar to those calculated for Shot 53. And yet Specimen #8 showed only silica coating removal over a limited region of the exposed specimen surface.

Figure 21. Lateral Stresses Calculated For Shot 53 – Specimen #6

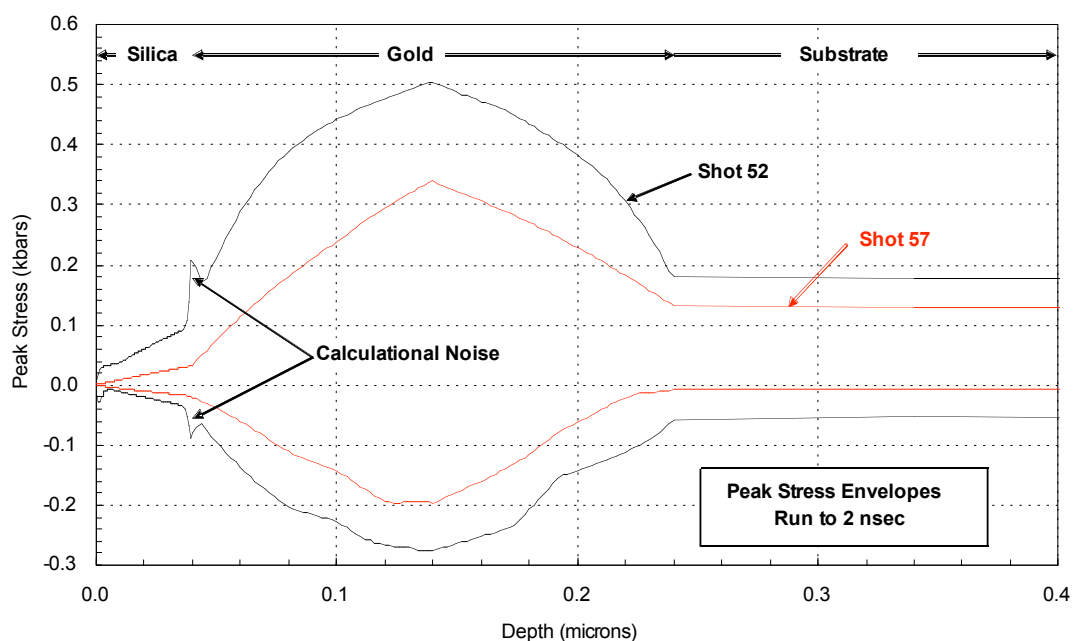
Figure 23 shows the calculated peak stress envelopes for Shots 52 and 57 run to 2 nsec. The silica coating was completely removed in Shot 52 and intact in Shot 57. There is some very early time noise in Shot 52 (the spike is actually calculated during the first hydrodynamic cycle and must be related to the zoning), but the trend indicates that the generated peak tensile stresses at the silica/gold interface could be nearly a factor of two larger in Shot 52 than in Shot 57. Spall or delamination of the silica layer may be the cause of the silica coating layer removal. However, there are large uncertainties in the material properties used and uncertainties inherent in the calculation itself.

Figure 23. Peak Stress Envelopes Calculated for Shots 52 and 57
